Field Notice

HysteroLux™ Fluid Management System Control Unit – REF 72205000

WOM reference no.: 2021-0002

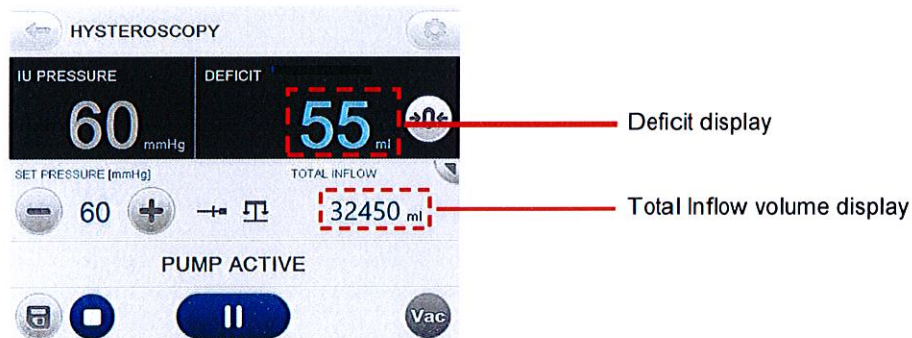
This field notification is being issued following reports from customers from the USA that the display of inflow volume on the HysteroLux™ Fluid Management System can reach its limit of 32,450 ml during long procedures. In these cases, the display does not indicate the actual inflow volume. In cases where an unusually high amount of fluid is used for distension of the patient's uterus, the calculation of the inflow and outflow volumes reaches its limit and the Control Unit display will freeze at the maximum value.

Our investigation has identified a software anomaly as the cause for this display freeze. The reason for this is that at 32,450 ml an internal software calculation threshold is being reached. As the outflow measurement will continue, the result is that the deficit accumulated up to this point will start counting backwards until 0 ml is reached.

Figure 1 Pump Control Unit display showing the calculated deficit (Deficit display) and inflow volume count (Total Inflow volume display). The latter will freeze, once 32,450 ml has been reached.

This incorrect display of fluid inflow can result in fluid overload. Fluid overload can be affected by distension pressure, flow rate and duration of the hysteroscopic surgery. It is critical to closely monitor the inflow and outflow of the distending fluids at all times. The pressure should be kept as low as possible to allow for a sufficient intrauterine distension and to reduce the forces that could allow fluid, ambient air, and/or gas into the circulatory system.

W.O.M. WORLD OF MEDICINE GmbH has developed a software version, which, when an inflow volume of 28.000 ml is reached, alerts the user that the limit is being approached and is designed to prepare the user for a manual determination of the deficit.

The new software version is implemented during the next preventive maintenance of your HysteroLux™ Fluid Management System Control Unit. If you wish to update the software of your device at an earlier date, please contact your sales representative of Medtronic Inc., who will assist in returning the unit and providing an exchange unit.
