Urgent Field Safety Notice

July 2022

Subject: Field Safety Notice – Continued use of older Model 2868 software on Model 3120 ZOOM™ programmers to support transvenous CRT-Ds and ICDs until supply chain constraints on newer programmers¹ are resolved. See Appendix A for affected GTINs (Boston Scientific Field Action Reference: 92822246-FA)

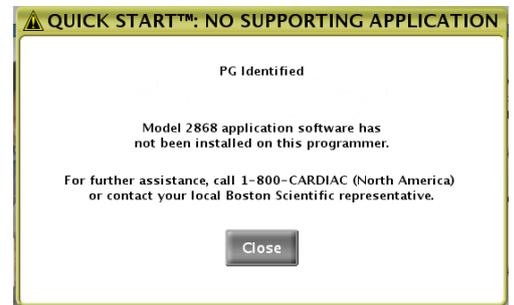
Figure 2. Message that displays when a Boston Scientific TV defibrillator is interrogated by a 3120 ZOOM programmer if 2868 software is uninstalled.

The behavior most likely to be attributed to potential harm when using a 3120 ZOOM programmer is the inability to interrogate a TV defibrillator (e.g. Figure 2 or 3). There have been 9 reports of this behavior which have resulted in a delayed/prolonged procedure until the defibrillator can be interrogated with a 3300 LATITUDE programmer. Furthermore, there has been a single report of delays in reprogramming for phrenic nerve stimulation and a single report of an inability to interrogate for delivery of commanded therapy. None of the reports associated with 3120 ZOOM programmer have resulted in permanent injury.

- 1) If unable to interrogate a TV defibrillator with a 3120 ZOOM programmer, use a 3300 LATITUDE programmer instead. If this behavior occurs, STAT PACE, STAT SHOCK, and DIVERT THERAPY programmer operations⁴ are not available through a 3120 ZOOM programmer, so external pacing/defibrillation or magnet application (to divert shock) may be required if a 3300 LATITUDE programmer is not immediately available.

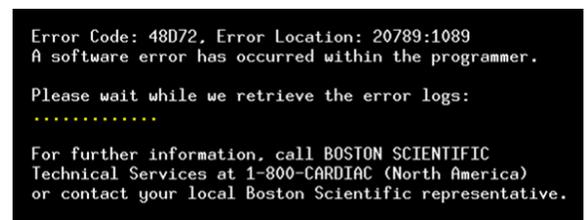
If a TV defibrillator has a stored SAM episode, the 3120 ZOOM programmer will present the Error Log and Halt message in Figure 3, and the user will need to use a 3300 LATITUDE programmer to interrogate the defibrillator. This error message (Figure 3) is an indication of an incompatibility of any 3120 ZOOM programmer with that specific TV defibrillator. However, the TV defibrillator will operate as intended with the permanently programmed settings. After power cycling the programmer, it may be used to interrogate TV defibrillators without stored SAM episodes. If the user attempts to interrogate the same TV defibrillator with the 3120 ZOOM programmer, the Error Log and Halt message will display again.

Figure 3. The specific Error Log and Halt Message on 3120 ZOOM Programmer when interrogation of TV defibrillator with a SAM episode is attempted.

A 3120 ZOOM programmer update to 2868 software has been developed to resolve the Error Log and Halt behavior associated with TV defibrillators having a stored SAM episode. This software update does not represent a material reduction in patient safety risk, however, it does prevent clinical workflow interruptions and will be released subsequent to approval.
