# **IMPORTANT PRODUCT NOTICE**

19-Apr-2023

RE: PIC iX 4.0.1 Settings Synchronization Issue with IntelliVue MX40

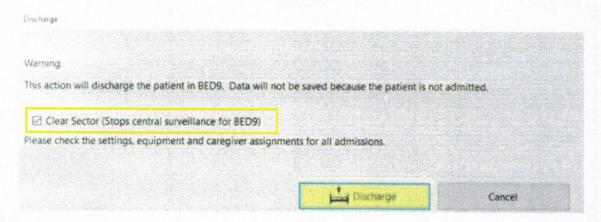
#### Image 4 - Clear Sector

- a. Identify the sector to be cleared from the PIC iX. These steps may be repeated for all sectors in use if they are not routinely cleared.
- b. Select the "Manage Patient" button and the "Manage Patient" window will display.
- c. Select the "Clear Sector" button and the discharge window will display.
- d. Check the box next to the "Clear Sector" option, as shown in the example Image 4 below:

e. Selecting the "Cancel" button does not change the sector assignment. Finalize the process by selecting the "Discharge" button.
