Name of Project:	UNO2
<b>Project Number:</b> (if available, e.g. from SAP)	N/A
Name of Product: (if available)	OPMI LUMERA 300

Our Ref.: FSCA -SHS-2023-001

# FSCA- SHS-2023-001, OPMI LUMERA 300, inspect (repair if needed) the suspension arm

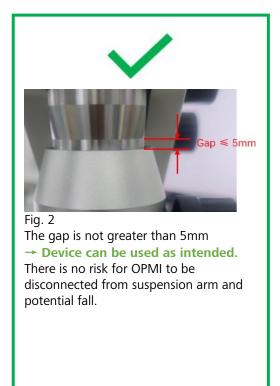
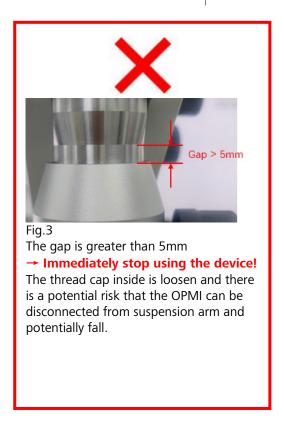
In certain devices there is a probability of specific screw missing during assembly. This screw is used to prevent one internal thread cap rotating which ensure the connection between suspension arm and the suspended components. The identified defect may lead to a potential risk.

arm may cause the suspended components fall from the suspension arm, it may lead to a potential injury to the person under the suspended components.

The gap shown is Fig 1 indicates the fasten status of thread cap (not visible) which carries all load of suspension arm. If this gap is not in its nominal value, there is a risk of OPMI falls from suspension arm.

Measure the gap shown in Fig. 1
If the gap is greater than 5mm, please Immediately stop using the device!
In this case the OPMI LUMERA 300 can no longer be used.

We are planning to inspect (repair if needed) of the suspension arm immediately. Our service staff will contact you to arrange an appointment for inspection (repair if needed) of the suspension arm. Please do not hesitate to contact your local ZEISS organization in case of any concern or question.
