Field Safety Notice, Medical Device Correction #109886

RayStation, RayPlan 9A, 9B, 10A, 10B, 11A, 11B and 12A including service packs

16th February, 2023 RSL-P-RS FSN Class III 109886

This notice concerns issues with DICOM export from the Virtual Simulation module and issues with import of Virtual Simulation plans in RayStation, RayPlan 9A, 9B, 10A, 10B, 11A, 11B and 12A including service packs.

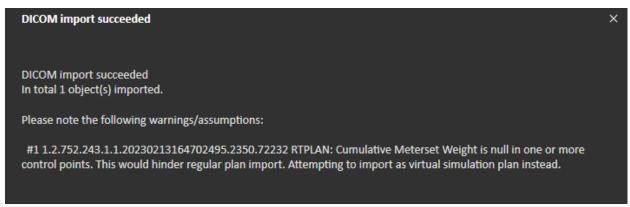
Figure 3. Example of warning displayed when Virtual Simulation import occurs.

If a plan is imported as a Virtual Simulation plan, the user is notified with an import warning which is also stored in the import log (see **Figure 3** for an example).

If this type of import is triggered there are some attributes that would typically be imported that are ignored. This includes, but is not limited to:

- Table Top Pitch Angle (300A,0140) will be set to 0 by the VSIM import
- Table Top Roll Angle (300A,0144) will be set to 0 by the VSIM import
- Any boli referenced by beams will not be set on the imported beam for an imported virtual simulation plan
- Any wedges included in the imported RT Plan will not be imported
- Any cones included in the imported RT Plan will not be imported
- If the RT Plan contains multiple control points with different MLC positions only the positions of the first control point will be converted into a virtual aperture block

There are several validations not performed for a VSIM import, that would typically generate warnings or block the import completely.

If dose is calculated for a plan imported as a Virtual Simulation plan, it will correspond to the plan in RayStation, but may not correspond to the original plan.

- Do not use or export Virtual Simulation plans with non-zero collimator angle, wedges or cones using the "VSIM Export" button.
- Be aware that a plan imported as a Virtual Simulation plan may not contain all intended information and that some attributes affecting dose may be different from the original plan.

- Always perform dose computation for imported Virtual Simulation plans before export. Do not use the "VSIM Export" for export of such plans.
- Educate planning staff and all users about this workaround.
