Norderstedt, 31.01.2022

FSN 524700045

FIELD SAFETY NOTICE (FSN)

Fluorocell PLT

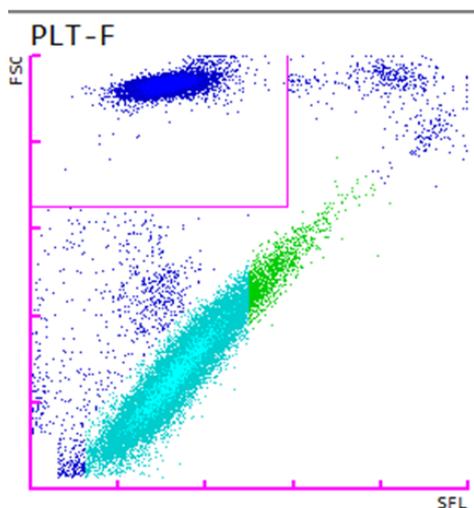
Item	Data	Unit
PLT-I	244	10 ³ /uL
PLT-F	244	10 ³ /uL
IPF	6.0	%
IPF#	14.6	10 ³ /uL

PLT-F-RBC-X	81.2	ch
-------------	------	----

PLT-F-X	85.2	ch
---------	------	----

Fig. 1: Sample with a correct PLT-F classification and normal fluorescence intensity

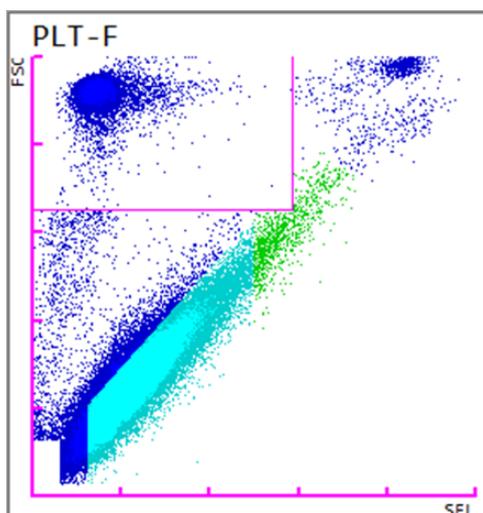
In some cases the PLT-F population was classified as debris and thus the PLT-F results have been underestimated. This is recognisable by a dark blue coloured portion of the PLT population (please see Fig. 2). In addition, the diagnostic parameters IPF (IPF %) and IPF# (IPF count) were potentially affected as well.

Item	Data	Unit
PLT-I	1132 *	10 ³ /uL
PLT-F	1027 *	10 ³ /uL
IPF	1.2 *	%
IPF#	12.3 *	10 ³ /uL

PLT-F-RBC-X	38.2	ch
-------------	------	----

PLT-F-X	51.0	ch
---------	------	----

Thrombocytosis

PLT Abn Scattergram

Fig. 2: Sample with a PLT-F misclassification and decreased fluorescence intensity

Analyse the PLT-F scattergram for abnormalities in the classification of the PLT population, as illustrated in the example above (Fig. 2).

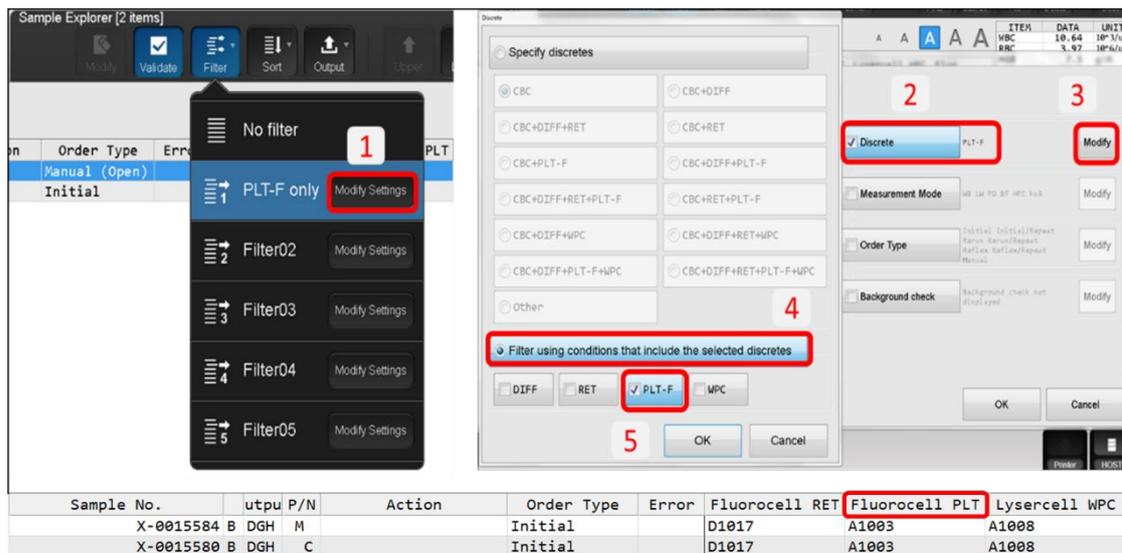
Fig. 3: Filtering of samples with PLT-F measurements. The Fluorocell PLT lot can be seen in the 'Reagent' tab for each measurement

Samples can be easily filtered in the sample explorer to focus on measurements with PLT-F, and samples with 'affected reagent lots' can be identified by using the 'Reagent' tab (see Fig. 3).
