Urgent Field Safety Notice

July 2022

Subject: Field Safety Notice – Continued use of older Model 2868 software on Model 3120 ZOOM™ programmers to support transvenous CRT-Ds and ICDs until supply chain constraints on newer programmers¹ are resolved. See Appendix A for affected GTINs (Boston Scientific Field Action Reference: 92822246-FA)

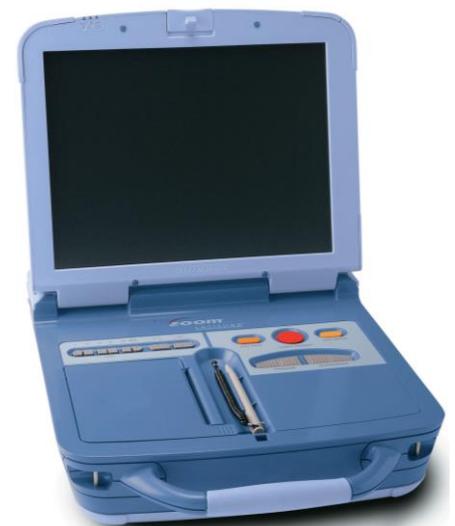
Figure 1. Model 3120 ZOOM Programmer

- Global supply chain challenges have constrained availability of the newer programmers.
- Until the supply chain constraints are resolved locally, you may continue using older 3120 ZOOM programmers.
- The 2868 software on the 3120 ZOOM programmer has been uninstalled or is outdated. As such, users may observe unexpected behaviors when attempting communications with transvenous defibrillators² including the potential inability to interrogate or the display of incorrect/missing parameters³
- A software update has been developed to resolve some of the disruptive behaviors associated with continued use of 2868 software on the 3120 ZOOM programmer. Boston Scientific will release software after local approval.

In facilities whose 3120 ZOOM programmers still have 2868 software installed, there may be unanticipated behaviors observed when interrogating TV defibrillators. The most common behavior observed is an inability to interrogate a TV defibrillator due to a Signal Artifact Monitor (SAM) episode. SAM is one of the new TV defibrillator features included in the enhanced software found on the 3300 LATITUDE programmer. SAM is designed to continually monitor the electrogram for Respiratory/Minute Ventilation (MV) sensor artifacts. If artifacts are detected or sensor vector lead impedance measurements are out of range, SAM either switches the vector or disables the sensor, and a SAM episode is recorded.

- The risk of insufficient programmer supply outweighs the risks associated with these unexpected behaviors, therefore, Boston Scientific recommends continued use of 3120 ZOOM programmers for transvenous defibrillators until sufficient supply of the newer programmers can be achieved locally.

Recommendations: Please distribute this letter to all users of the 3120 ZOOM programmer and complete/return the Acknowledgment Form. Continue using 3120 ZOOM programmers to interrogate Boston Scientific TV defibrillators, as needed, with the following in mind:

Please complete the attached acknowledgement form, even if you do not have a 3120 ZOOM programmer (Figure 1 and Appendix A). We appreciate your consideration while we work through these supply chain challenges. When an adequate supply of 3300 LATITUDE programmers is achieved within the country, Boston Scientific will resume uninstalling 2868 software from the 3120 ZOOM programmer.
