# FIELD SAFETY NOTICE ALERT

## Team3 Fetal Monitor

Resolution in summary:	Upgrade Fetal Monitor with revised software (v19.4)
No pages:	15 inclusive of the declaration form

## FSN01-23

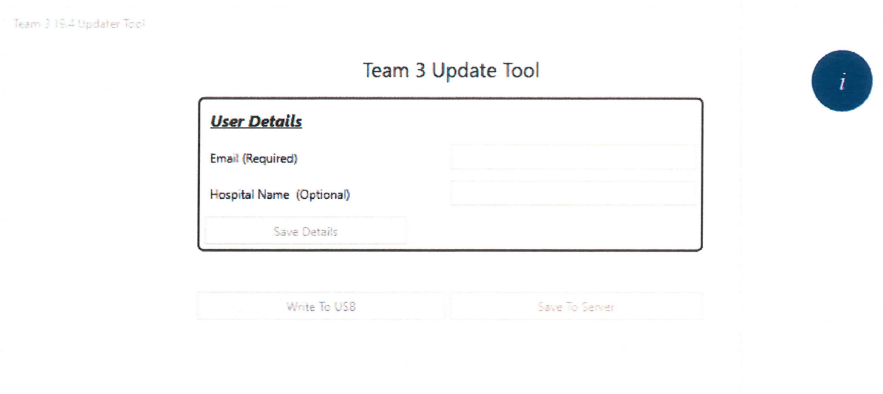
The following main screen will be displayed. Note that on first run, all of the control buttons are greyed out and unavailable. This will be the case until a valid email address is entered in the appropriate field.

- Enter a valid email address – the 'Save Details' button becomes available
- Optionally enter hospital details and click on 'Save Details' button
- Click on 'Write To USB' button which is now available

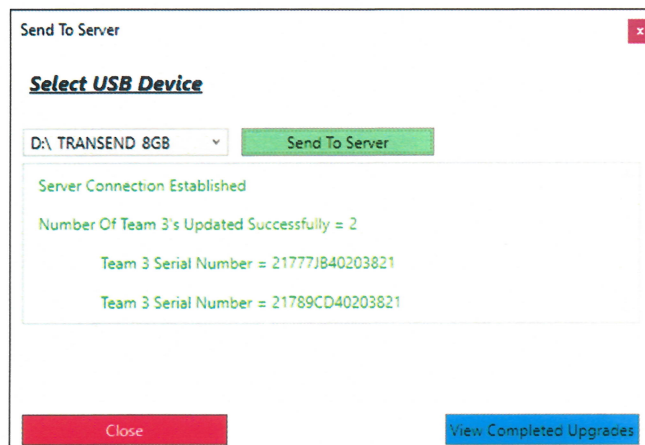
Click on the 'Send To Server' button to display the Send To Server dialog box.

Select the upgrade USB stick from the drop down list and click the 'Send To Server' button. A list of the Team3 Units upgraded using the stick is displayed in the scrollable message box. If a server connection could not be made, please try again later.
